First Christian Church Tower Renovation

FIRST CHRISTIAN CHURCH
531 FIFTH ST., COLUMBUS, INDIANA

Introduction

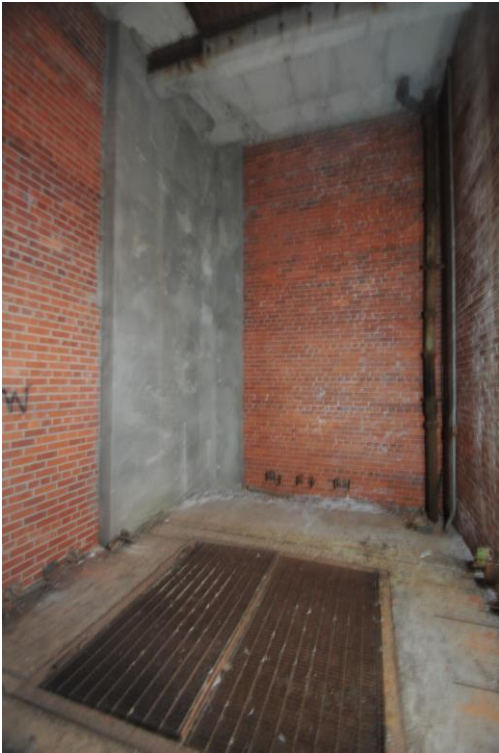
The grating in each floor had rusted and determined to be dangerous to open and close. The sump pump was on its last leg and needed replacing.

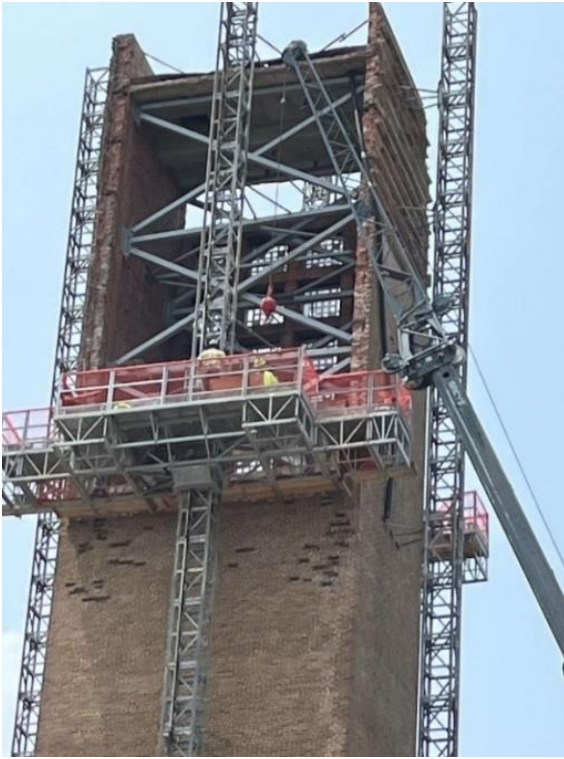
Just below the platform in the photo above, bricks were removed (dark spots) because they were cracked or damaged beyond repair. New bricks were mortared in their place.

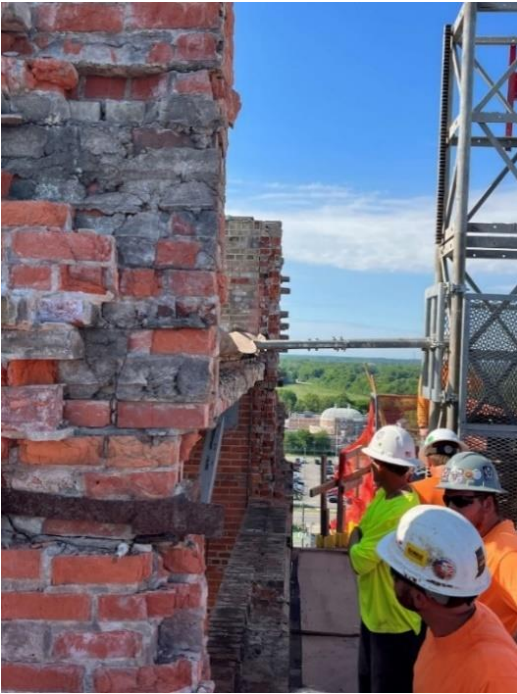
Water and its freezing and thawing over the tower's life, had caused a significant amount of damage high on the tower's NW corner in and around the zipper. The weakened brick was removed and the architect, engineer and contractors devised a fix using stainless steel cable, rebar and epoxy mortar to stabilize the existing wall. The damaged sections were rebuilt and tied together forming new stable wall sections.

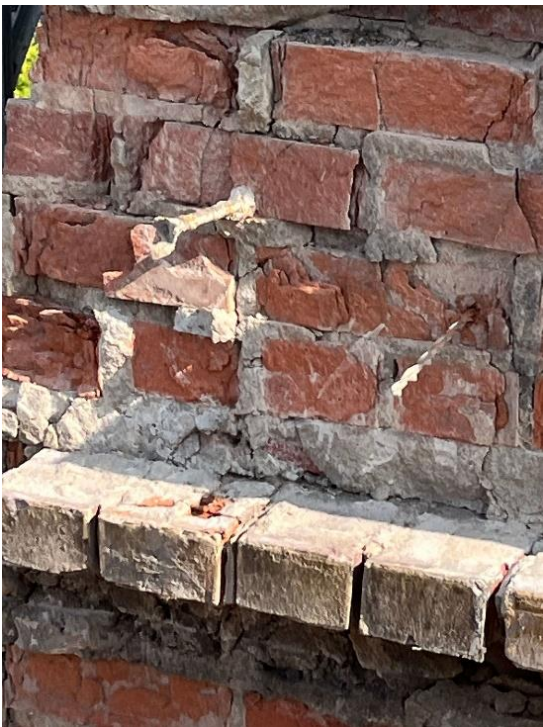
A closeup photo of exposed brick at the top of the tower was typical of the conditions found on the north and south faces. The bricks that were placed in a header position remained unless they were damaged beyond repair. The outer course of horizontal or stretcher bricks were removed and replaced with new or reconditioned bricks. When courses of new stretcher brick were added back, all of the joints were cleaned, filled with new mortar, repointed, struck and cleaned again. These were stained to match the old brick if

necessary. The pins and spiral anchors can be seen, in the above photo, were repairs added over the years to help hold the original brick and mortar together.

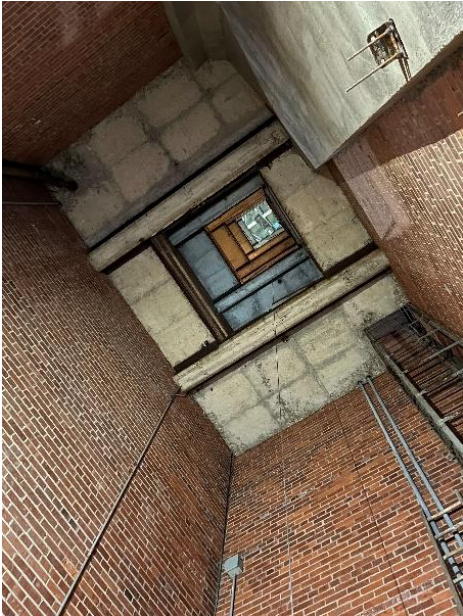
Over the years the grating and frames had corroded and needed to be replaced. These were removed along with the rusted steel ladder between floors. New galvanized steel frames, gratings and ladders were installed. In addition, new lighting at each level was put in place

along with drainage piping from the roof to the sump pit in the lowest level. The photo above was taken from the first level looking up through the openings in each floor to the roof.

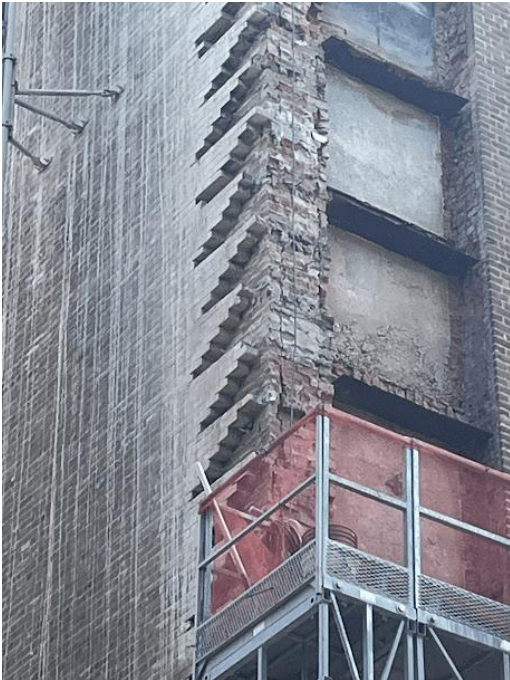
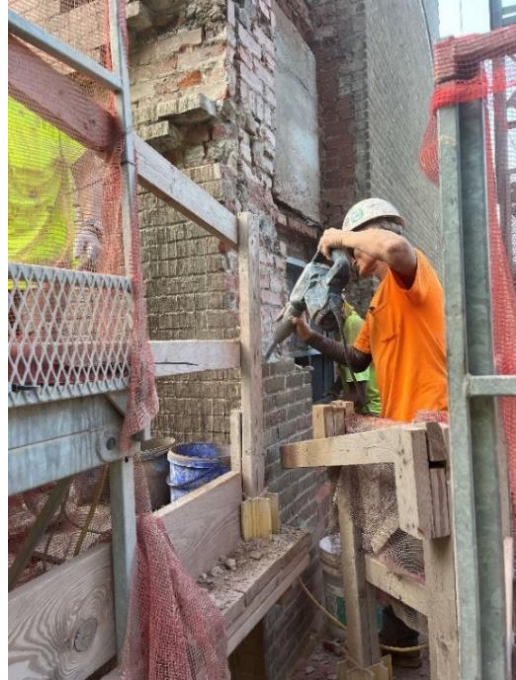
The tower's NW corner adjacent to the zipper openings had deteriorated much more than the other three corners. In the early years of the tower's existence significant cracking was observed in this area. Engineers determined this was due to the impact that the original openings had on the overall tower structure. The remedy, installed in the mid 70's, was to

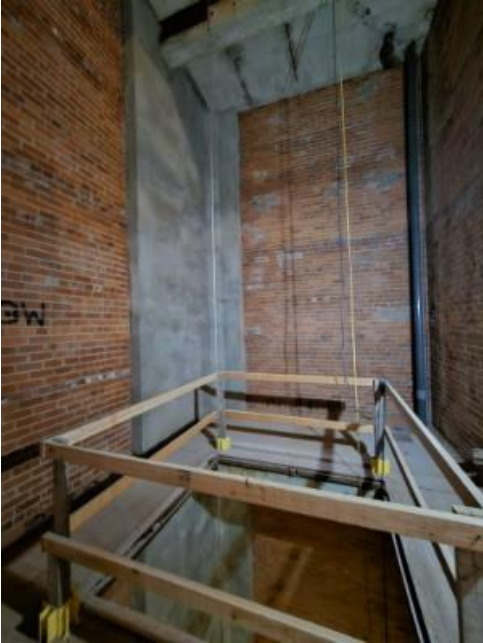
pour-in-place a concrete backup patch behind the zipper on the inside of the tower from the first floor to just below the bell chamber, as seen just left of center in the photo below.

The thinking was that this patch would stop, or at least slow down, the damage to the tower from the movement which was causing this corner to undergo more damage and consequently repairs, than in the other three.

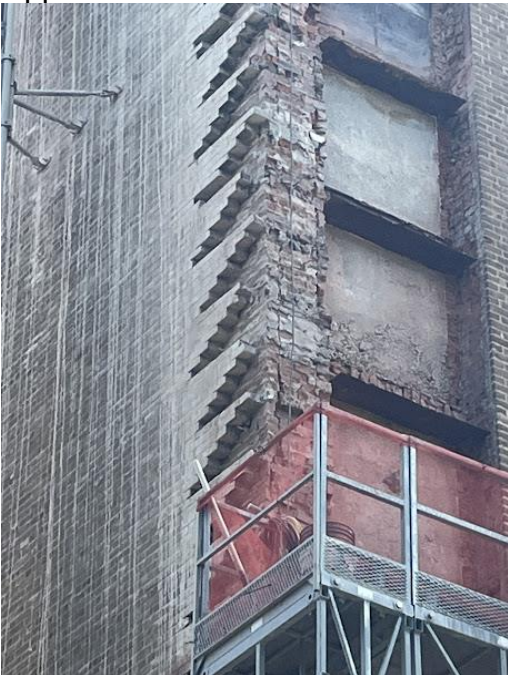
The impact of the motion to the zipper frames, corner brick and the masonry on the north face, can be seen in the photo below where the damaged face brick was removed. Also, the concrete patch placed on the inside of the tower zipper is evident along with the corroded zipper lintels.

The original zipper repair plan, was to replace the horizontal steel lintels with new and then add the brick frame for the limestone panels. After seeing the damage underneath the face

brick in and around the zipper, the engineers developed a new fix that required the removal of the steel lintels entirely. These were not replaced.

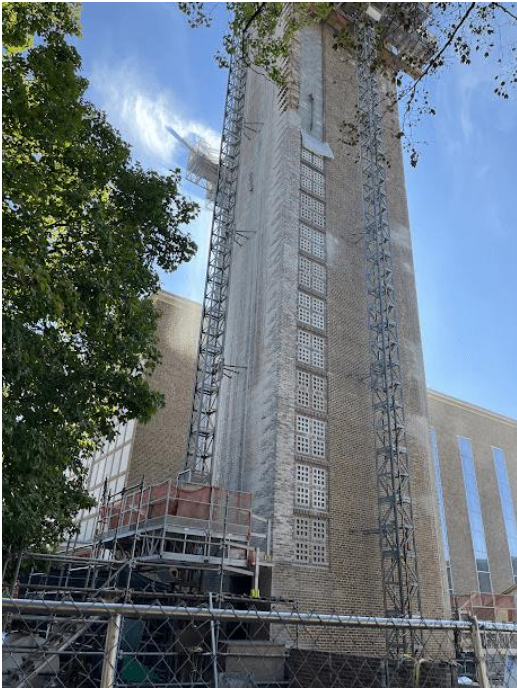
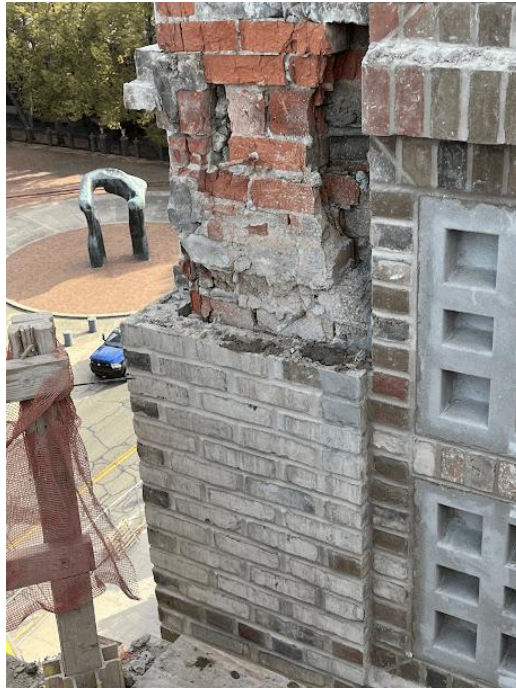
Work continued to rebuild the zipper (left photo above) and the adjacent brick along the NW corner of the tower. A close-up photo (right above) illustrates the water damage and freezing and thawing harm that was the result of the original open grid construction. The brickwork below the damaged area is new.

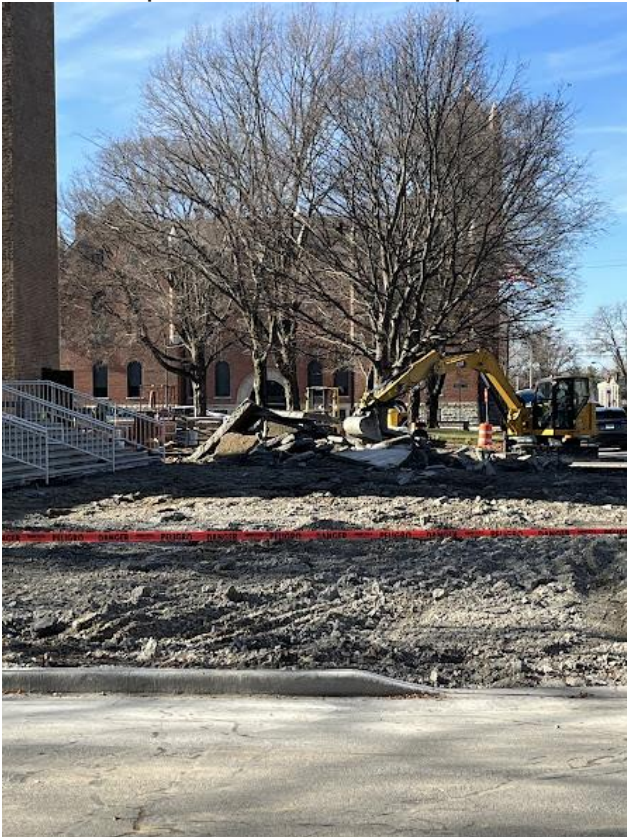
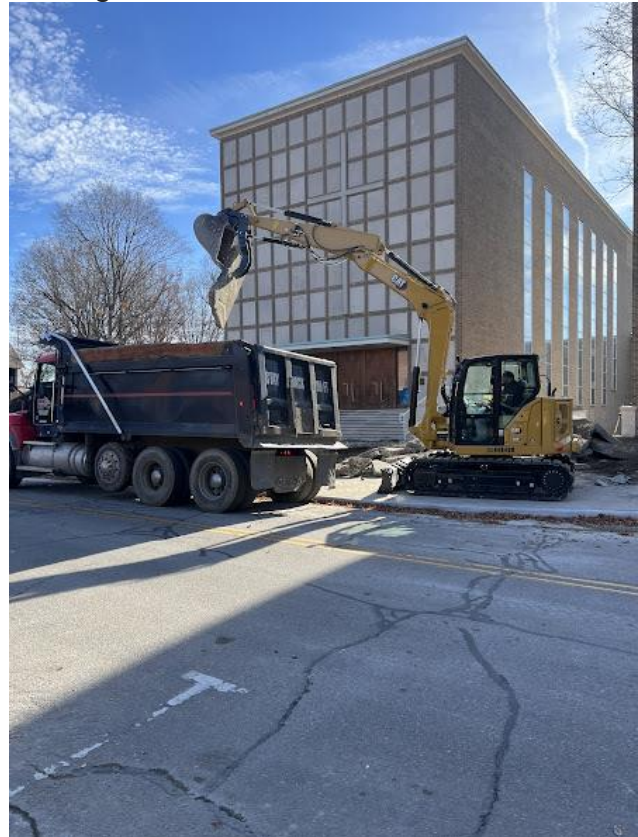
The tower construction went well, up to this point. As the project's end was in sight, Wilhelm ran into their first major hiccup. The newly poured concrete in the plaza area did not have enough accelerant admixture in the mix for it to set quicker than normal in the cold weather that was encountered. Without adequate accelerant, the concrete did not set properly and when it was power washed the next day, too much of the surface was removed exposing more aggregate than desired making the surface very rough. Also, the "softer" concrete was damaged along the freshly saw-cut control joints during the washing process. Because they were not satisfied with the quality of the concrete finish, Wilhelm immediately made arrangements to remove and replace the entire concrete plaza area. The two photos below are of the plaza with the unacceptable concrete, being removed.
