First Christian Church Tower Renovation

FIRST CHRISTIAN CHURCH
531 FIFTH ST., COLUMBUS, INDIANA

Introduction

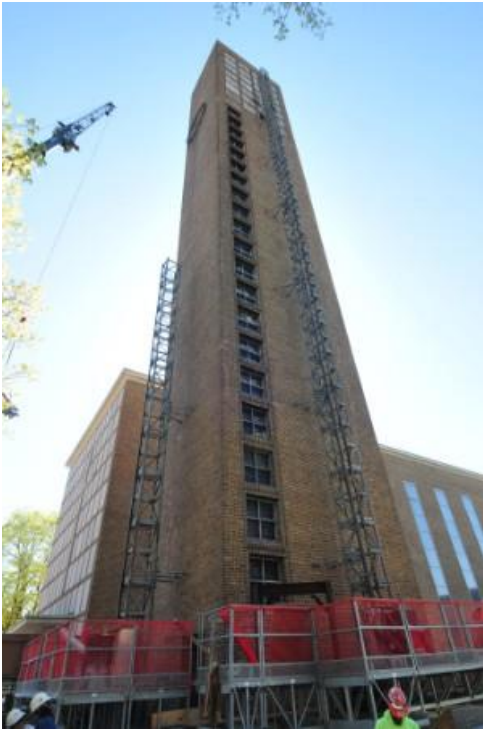
By mid-April, Wilhelm had begun removal of the “zipper”, a vertical line of openings on the west tower wall while the lift platform was being installed on the north face. Interior structural steel was starting and other materials for the project were arriving.

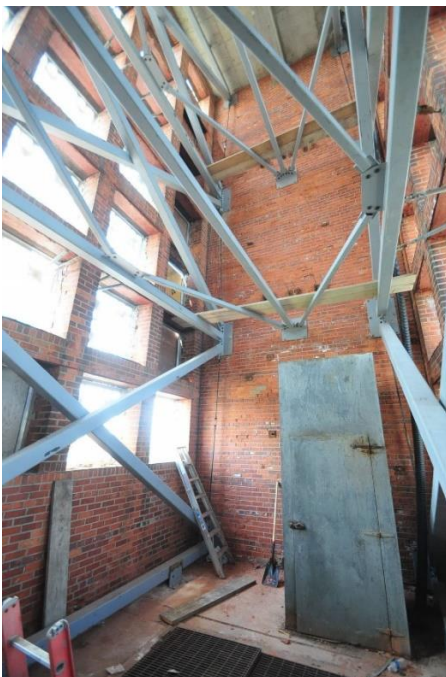
During early stages, much work was done to stiffen the clock chamber on the inside of tower by adding structural steel that supported the north and south walls. The existing brick framework around the windows on the east and west side walls was being torn down for

reconstruction at the same time. The original intent was to remove these steel members once the planned work in the bell chamber was complete, but the engineers decided to leave them in place to improve the tower's rigidity.

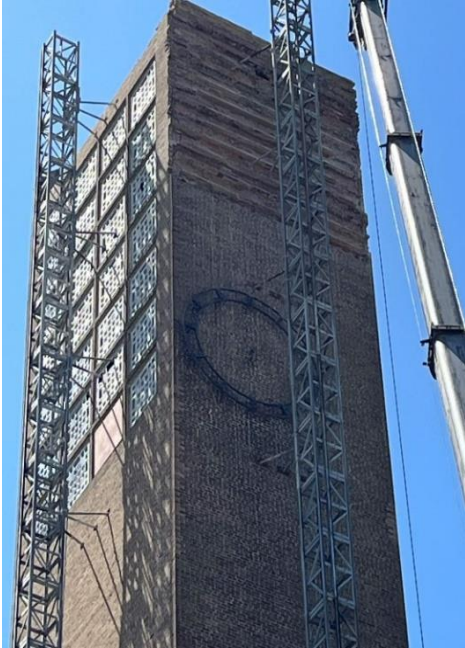
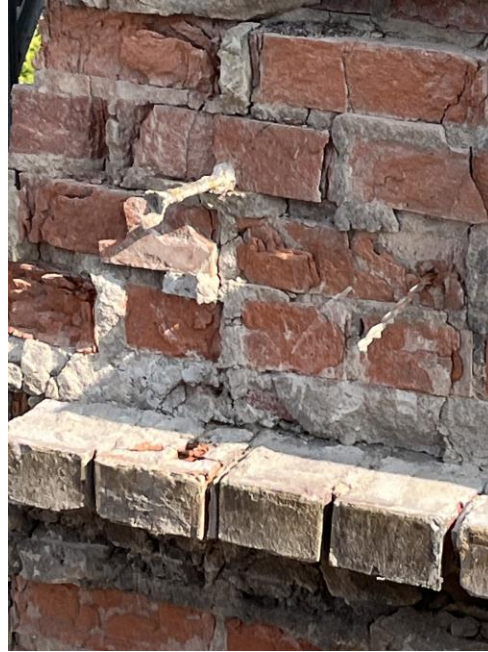
The exterior brick rework on the clock face wall began. The horizontal rows of brick that can be seen in the left photo on the clock face wall just above the clock, are bricks placed in a "header" position, also shown in the right photo. This pattern is common throughout the church. The six rows of brick in between the header rows are laid in the "stretcher" position. When all mortared together the header rows tie the brick face back into the tower structure for strength and structural integrity.

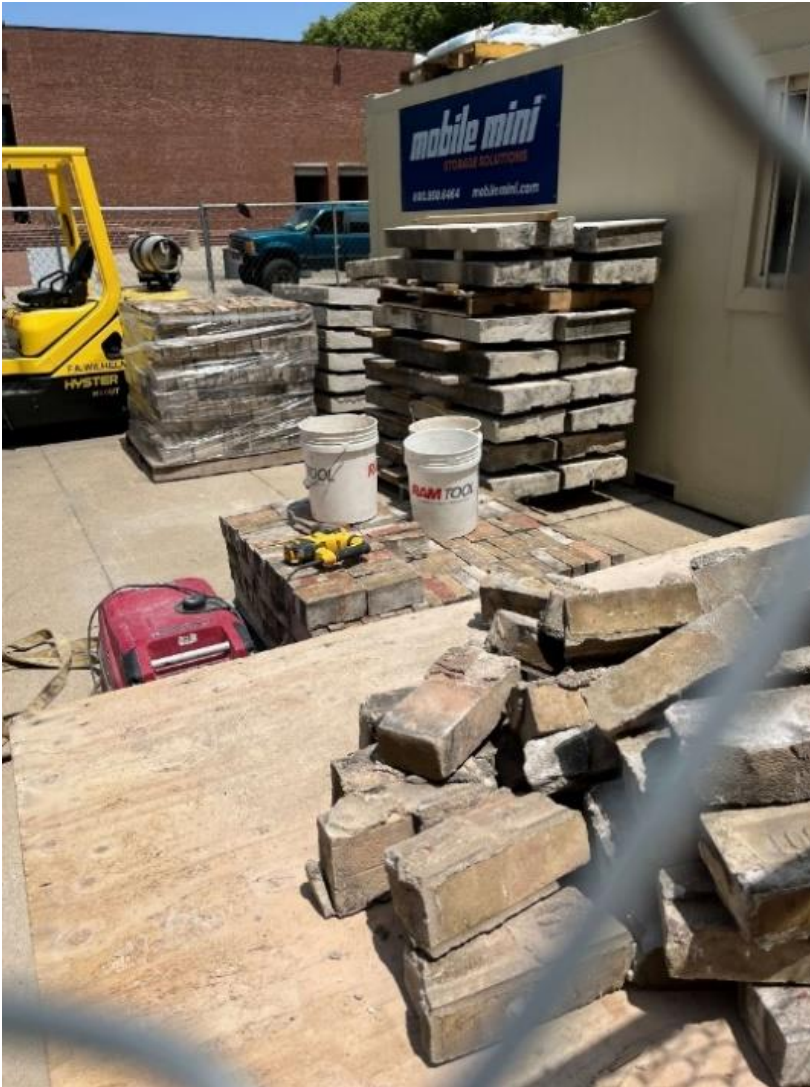
The face brick that was salvageable was removed from the tower exterior then inspected and cleaned for reuse. Approximately 70% of the original brick was able to be reused. This resulted in the need to stain and color match less of the new bricks with the old. In the above photo, the recovered brick was stacked and protected in shrink wrap. The limestone coping, adjacent to the construction building, was cleaned and later returned to the top of the tower's parapet wall. Bricks in the foreground were waiting for review.

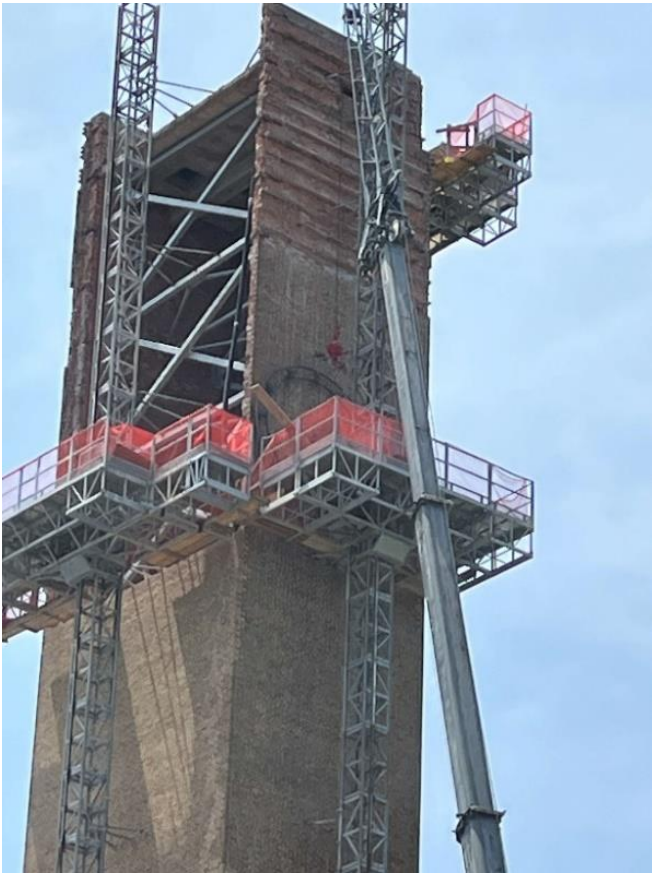
The brick window framework from the east side of the tower around the "window" openings was completely removed to allow for installation of the structural steel frame in the clock chamber. This steel remains in place and will "stiffen" the upper third of the tower. From this same photo, workers are seen removing the clock face.

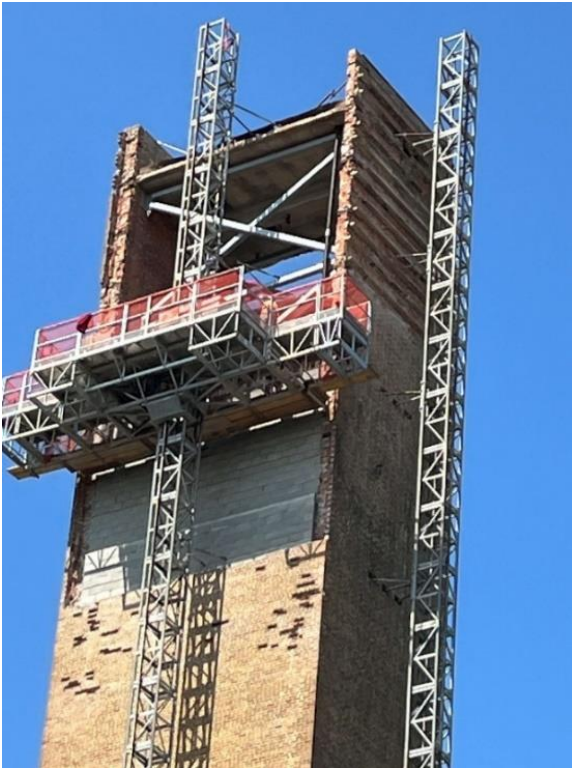
In the photo above, workers have started installing the interior concrete block wall on the east side of the clock chamber. This wall and its companion wall on the west side, further

strengthened the upper third of the tower. These walls were faced with a brick grid and limestone panels, replicating the original window layout.

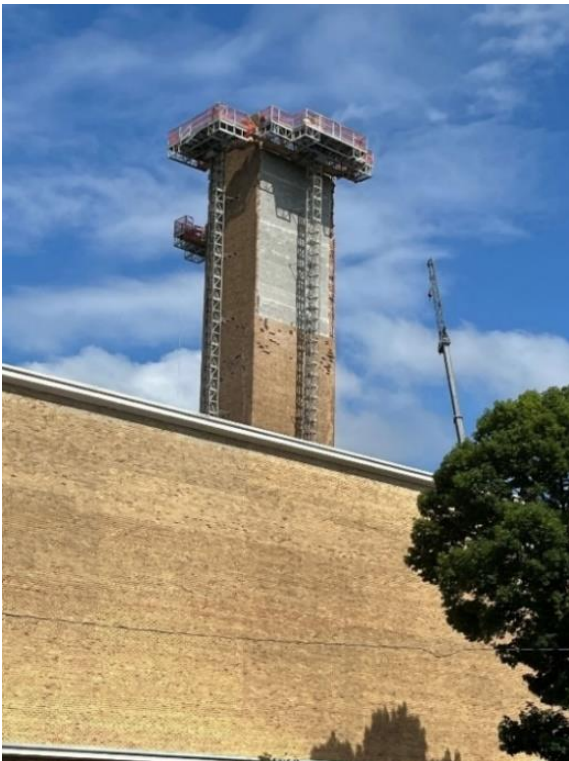
Tower reconstruction progressed well. The interior block wall on the eastern side of the upper third of the tower was completed and tied into the original north and south walls. Wilhelm completed the parapet wall (perimeter wall above the roof) on the east side.

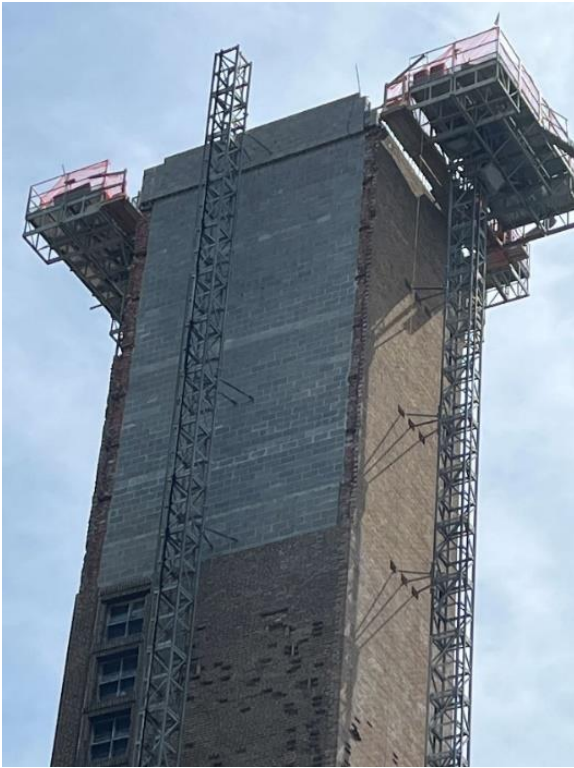
Wilhelm continued the tower reconstruction, with both the east and west upper inner concrete masonry unit (CMU) walls or more commonly known as concrete block walls, completed. These new walls, in the upper chamber, are significantly more complex than what is seen from the outside. As the concrete blocks were being laid up, two three-quarter-inch diameter reinforcement bars were laid horizontally in between every fifteenth course of block. These bars were then epoxied into twelve-inch-deep holes drilled into the existing brick on the adjacent wall. On the same course, two three-quarter-inch diameter rebar were mortared into the entire width of the new north and south block walls. The result being the existing north and south brick walls are now tied together with this steel reinforcement across the width of the new east and west concrete block wall. In addition, at every four feet up the new and old wall corners, a four-foot stainless steel cable was drilled one foot into the existing brick wall, then turned ninety degrees and extended three feet and epoxied into channels cut into the new concrete block wall starting at the floor level of the clock chamber to the roof.

Holes for vertical rebar were drilled into the existing brick wall at the base of the new CMU wall every eight inches and the rebar was epoxied into place. Concrete block was then laid over the rebar horizontally across the face in eight-inch courses resulting in vertical steel bars in each of the block cavities from the bell tower floor to the roof. All of the block center cavities were filled with mortar as the wall construction continued.

After curing, the result is a solid CMU wall reinforced vertically and horizontally and tied into the existing north and south tower faces. These walls were then covered with new limestone and brick emulating the original tower grid openings. This design and build resulted in a significantly stronger and more stable structure.

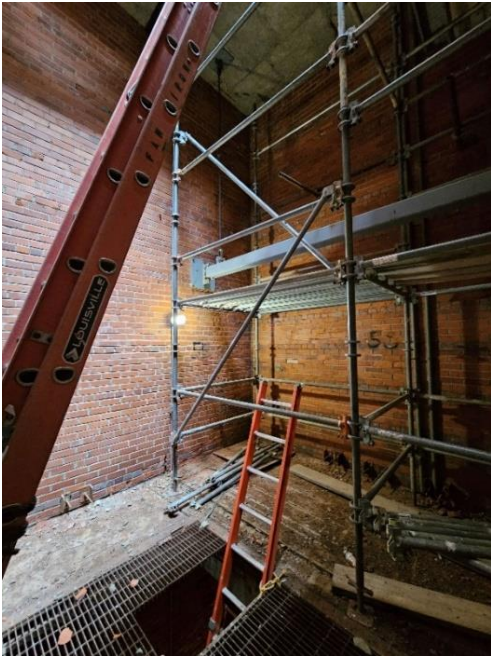
This photo shows the inside of the tower with the new steel bracing, surrounded by temporary scaffolding, that was permanently attached to the wall on level E, which is just below the clock chamber. This steel along with the new steel structure in the clock chamber will help to further strengthen the whole tower.

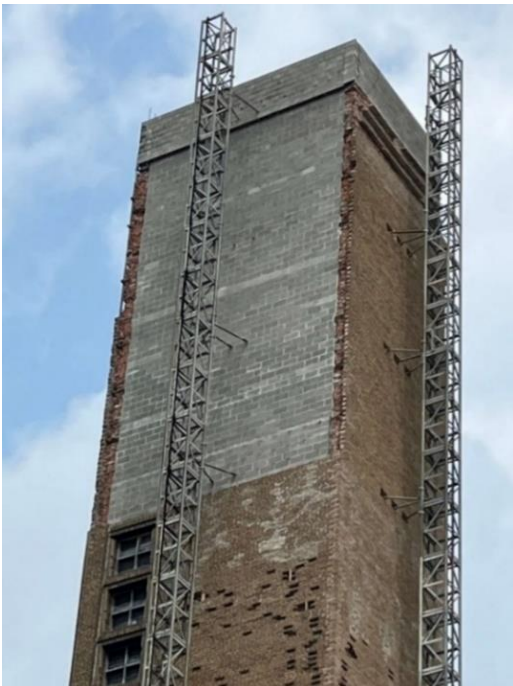
Concrete block walls on the east and west faces were completed along with the parapet walls, at the top of the tower, on all 4 sides. Structurally this was a major milestone. The walls and inner support steel that were added in the clock chamber and level immediately below, greatly improved the tower's stability. In the photo above, you can see where "new" bricks were patched in (appear as light-colored bricks) to the areas just below the block wall

where damaged bricks were removed. The dark spots on the tower, just below the area with the new bricks, are where old broken or spalled bricks were cut out and were waiting for replacement. These areas were cleaned and stained to match and blend in with the original brick.

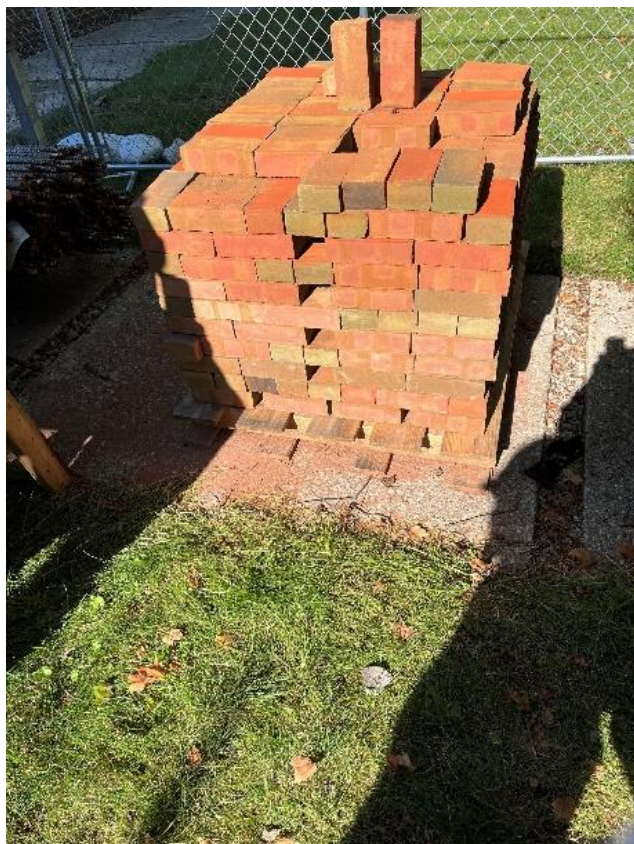
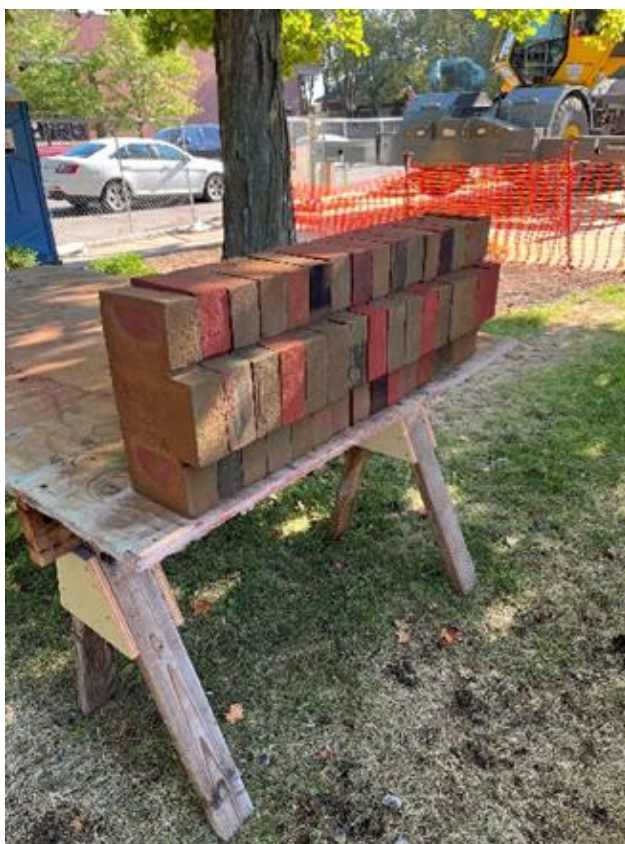
New bricks (left) arrived and were stained prior to installation to closer match the original tower. These pieces were used to rebuild the frames around the zipper windows and trim the limestone panels in the clock chamber grid. Others supplemented the original brick and filled in where damaged bricks were cut out and removed from the tower walls. Some bricks were stained prior to installation and then stained again or "touched up" in place after installation was complete.

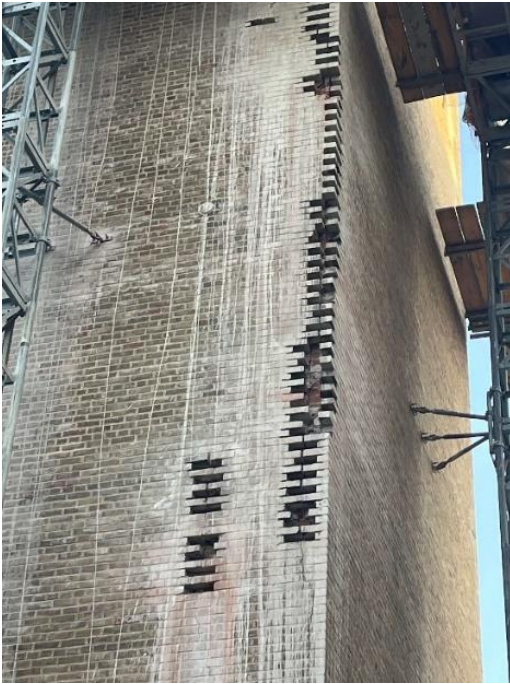
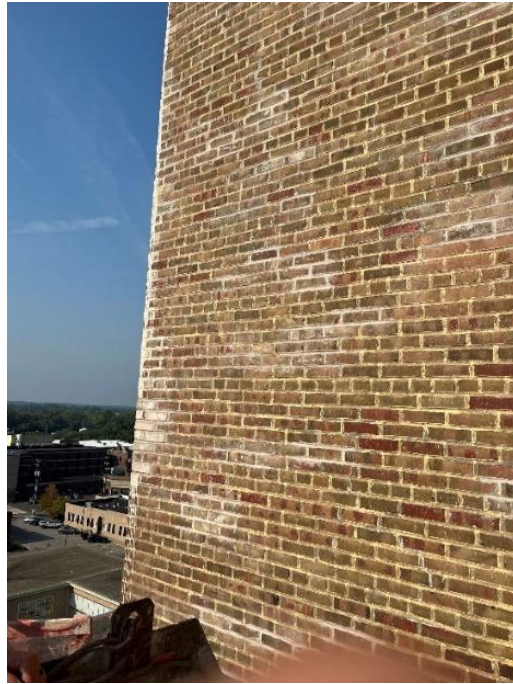
Wilhelm continued to remove and replace brick on the faces of the tower. In the photo on the right, one can see the new bricks surrounded by a lighter colored mortar. These bricks and mortar were later cleaned and stained to match the original surrounding masonry.

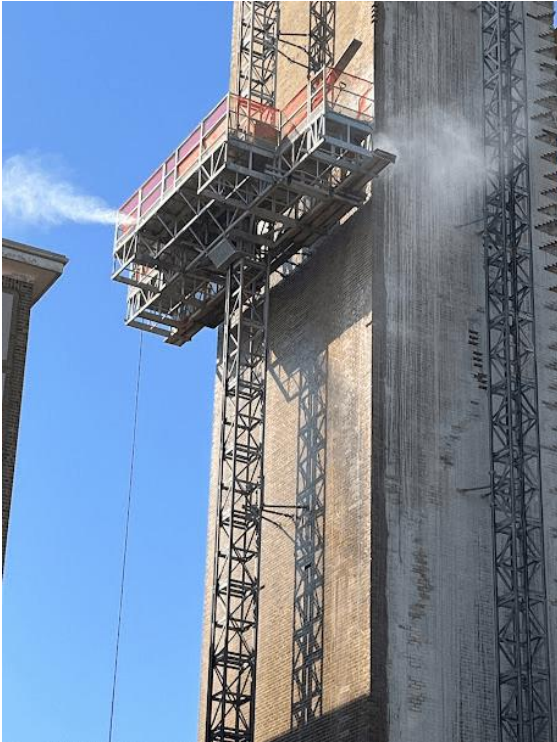
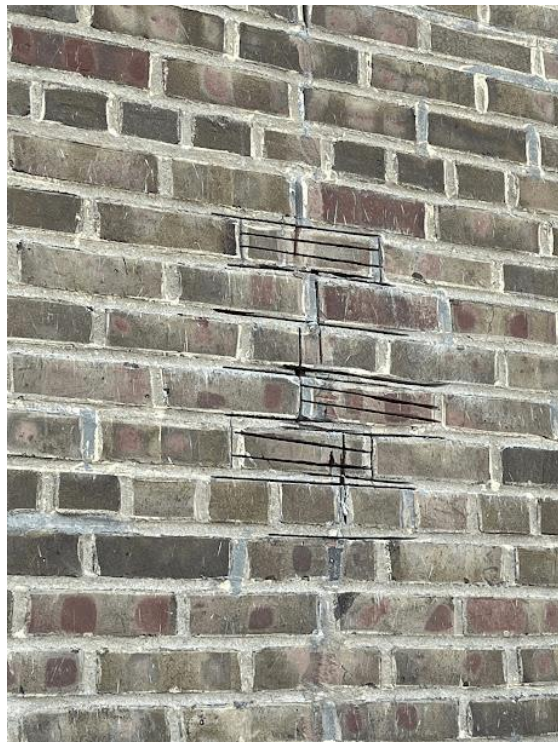
The east face of the tower was power washed (left photo) to remove all of the dust and debris that accumulated during initial stages of the renovation. This was done to ensure that smaller cracks (right) were visible so repairs could be made. These cracked bricks were saw-cut ("black lines" on the bricks) for removal. Additional cleaning was completed prior to the final staining process.

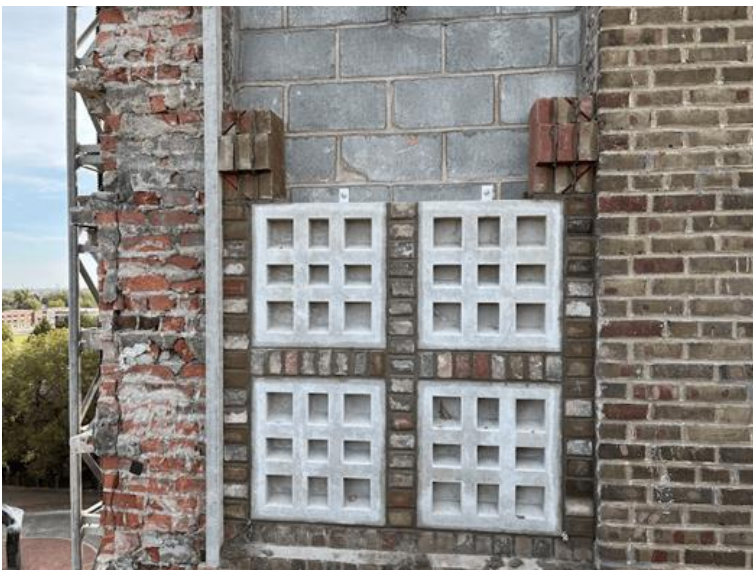
This is a close-up of a limestone zipper panel and its new brick trim (rowlock course) that was placed to appear as four separate panels when complete. Only one stone panel, which weighs about 1000 lbs., was set every day so that the mortar between the bricks and panels

could cure and strengthen. The new concrete block wall, that can be seen behind the panel, is new and was attached to the original concrete patch. Stainless steel clips can be seen at the top of the limestone. These attach the panel to the block wall while the perimeter brickwork was completed.

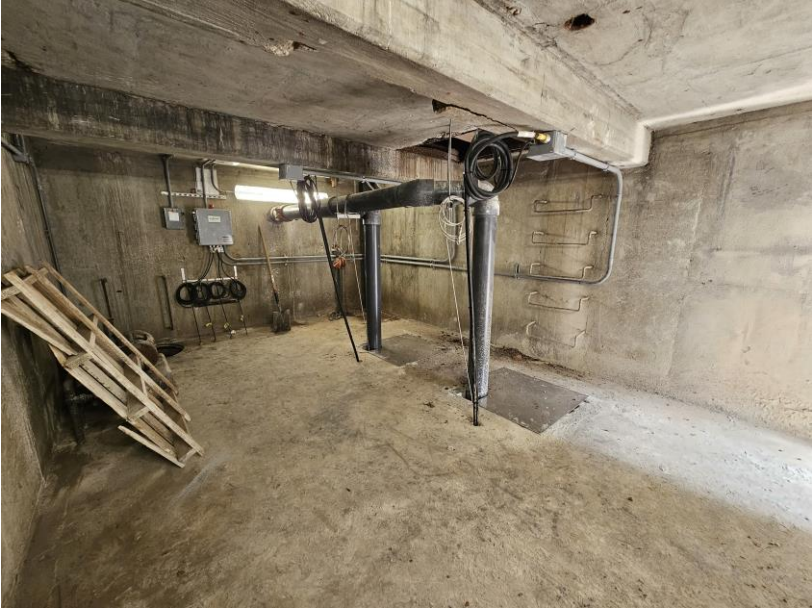
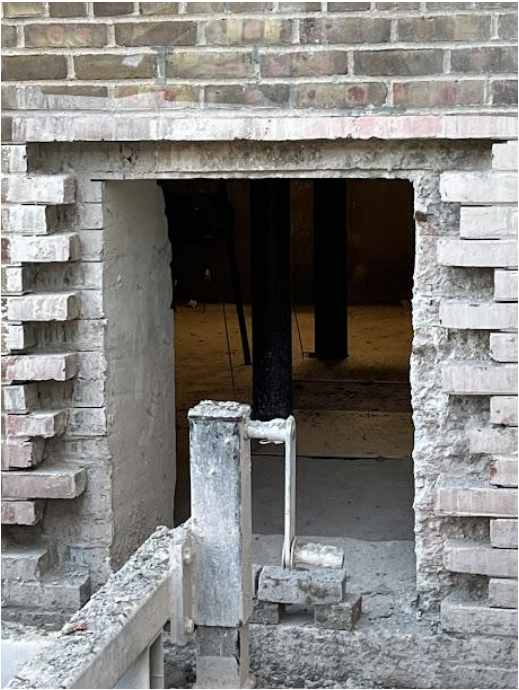
To prevent moisture from collecting on the tower's interior during the spring and fall and to prevent the interior brick from spalling, an opening was created in the wall at the lower level for a ventilation fan and louvers to be installed.

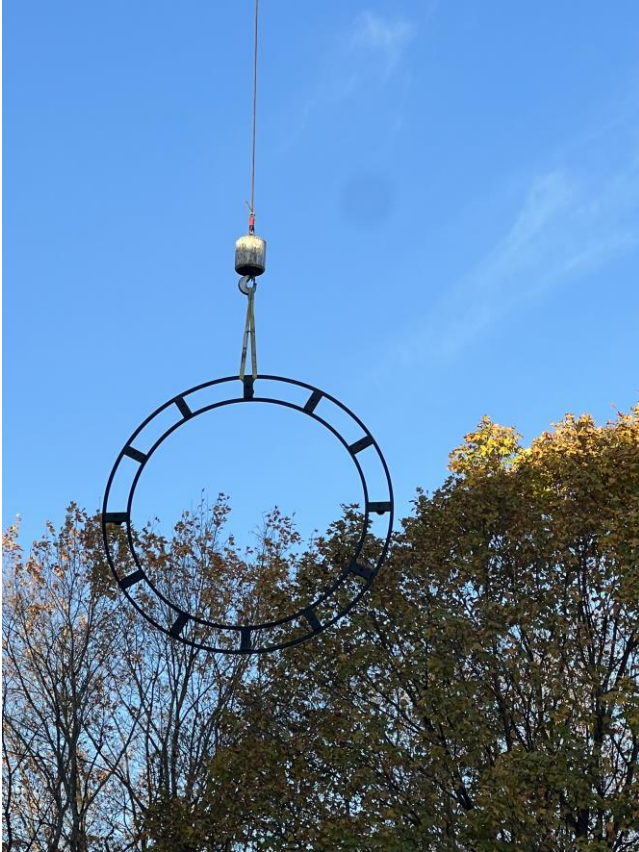
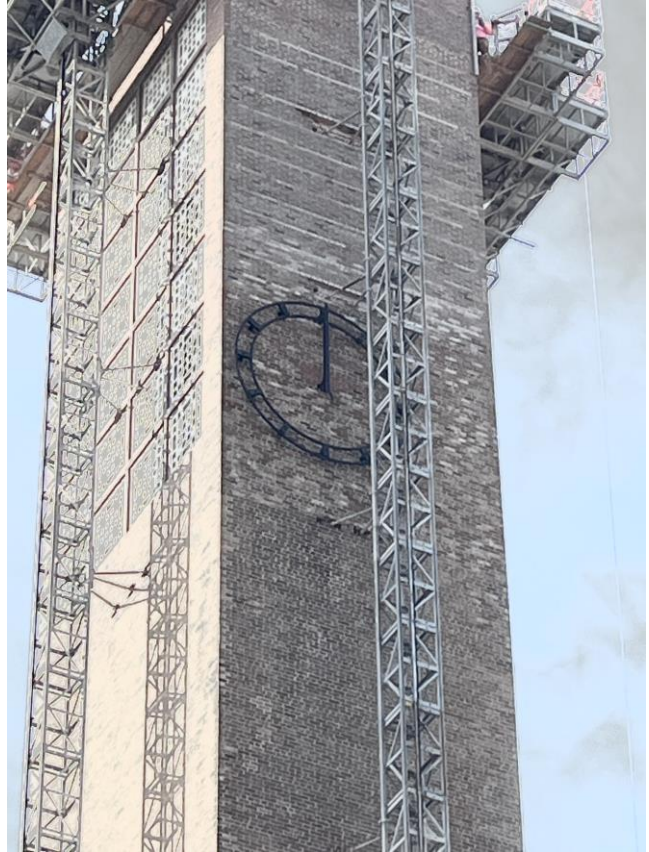
The clock face was sent to a company in St. Louis where it was cleaned, refinished, then returned and reattached to the tower wall. New hands were cast and installed on a modern drive unit replacing the original Seth Tomas clock works. The new clock is now able to be controlled and adjusted from the ground level using a cellular phone.

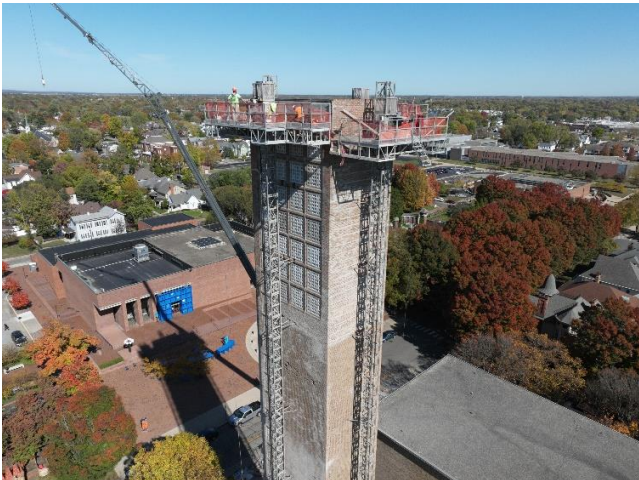
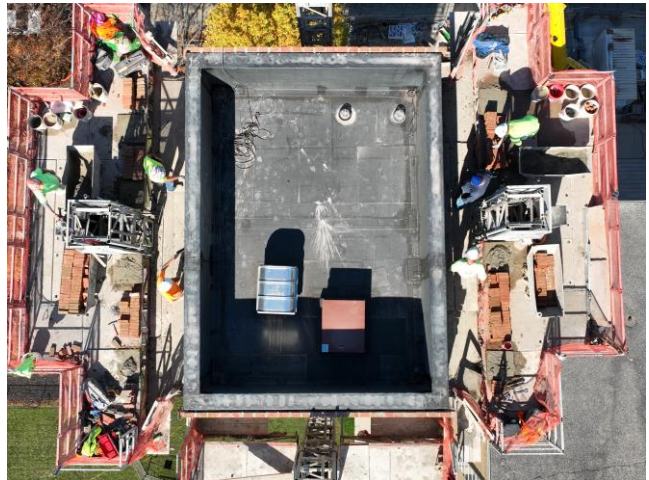
The completion of the brick masonry on the parapet walls and the corners of the outer clock chamber were completed. Wilhelm bricklayers finished their work around the parapet (left photo below). The right photo is looking straight down on the tower from above, with the new rubber membrane roof in the center and work platforms on the east and west faces.

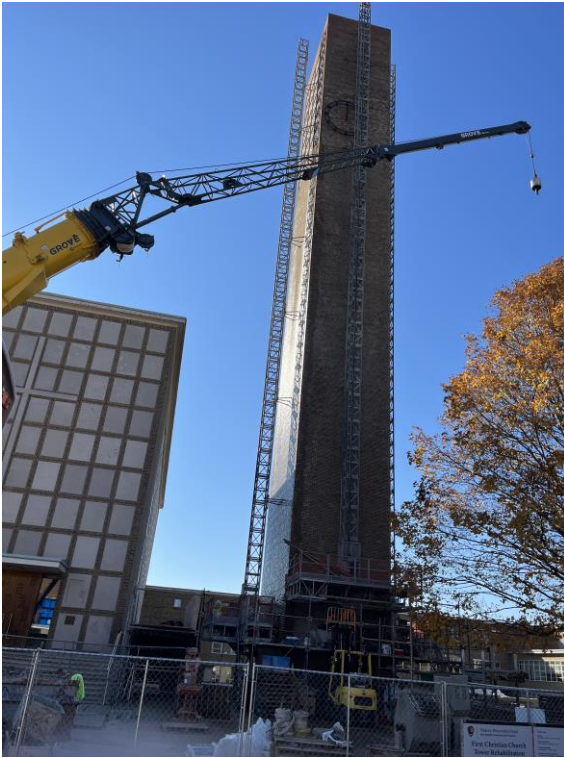
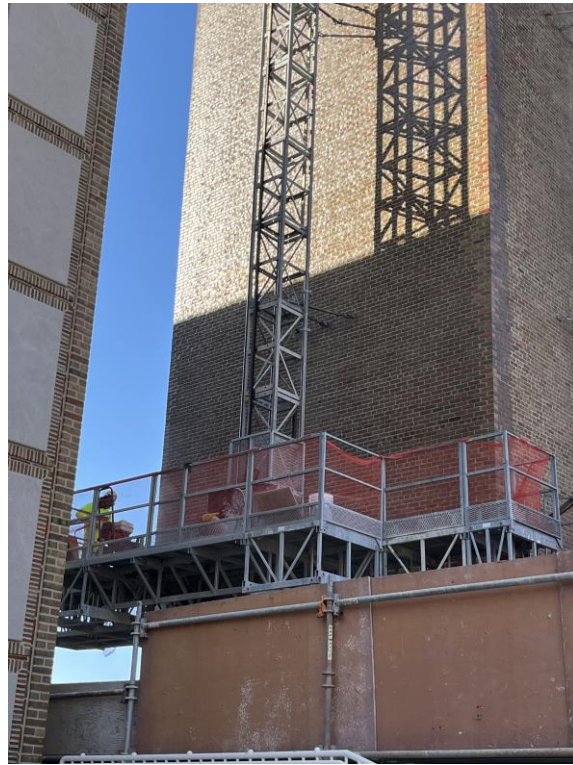
The sheen on the tower in the left photo below, is the result of water from power washing to remove all of the dust, mortar and dried on saw cut dust from the various repairs completed on the brickwork. The right photo is a closer view of the washing process. The power washing removed construction debris and allowed the best comparison between original and new bricks before final staining.

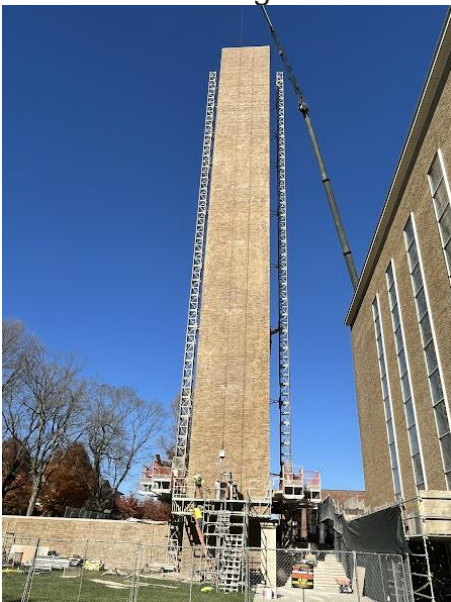
The focus then turned to staining the new bricks that were placed in the tower wall. The photo below is the south side of the tower: the staining and minor repairs were completed and the scaffolding removed.

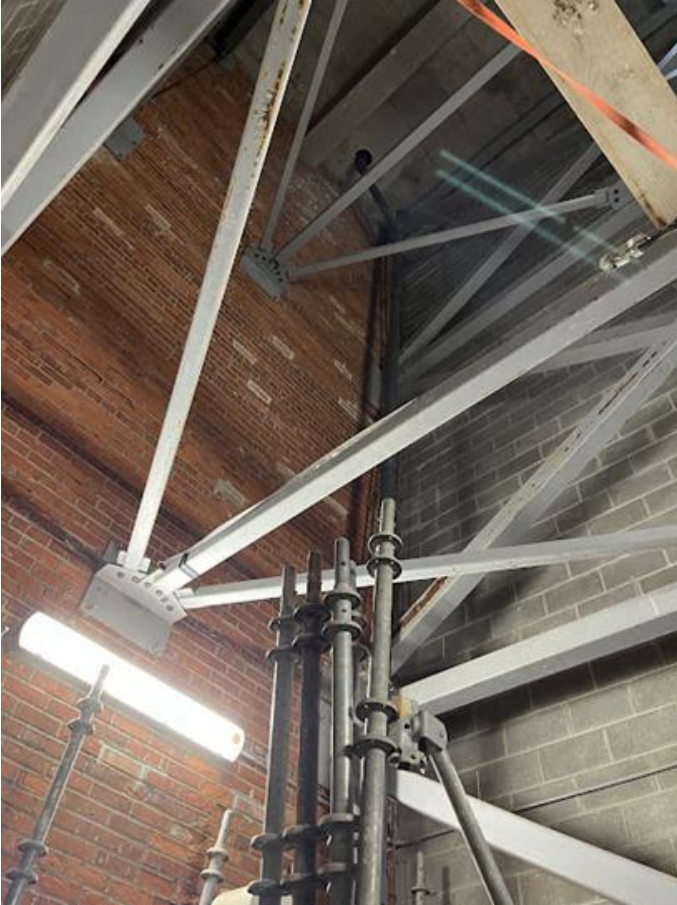
As noted earlier, significant structure of square tubing was added to the 5th floor and bell chamber above it. This was to strengthen the uppermost portion of the tower to minimize movement.

Earlier photos showed this ironwork from the exterior but the photo above shows it from the bell chamber floor looking up.

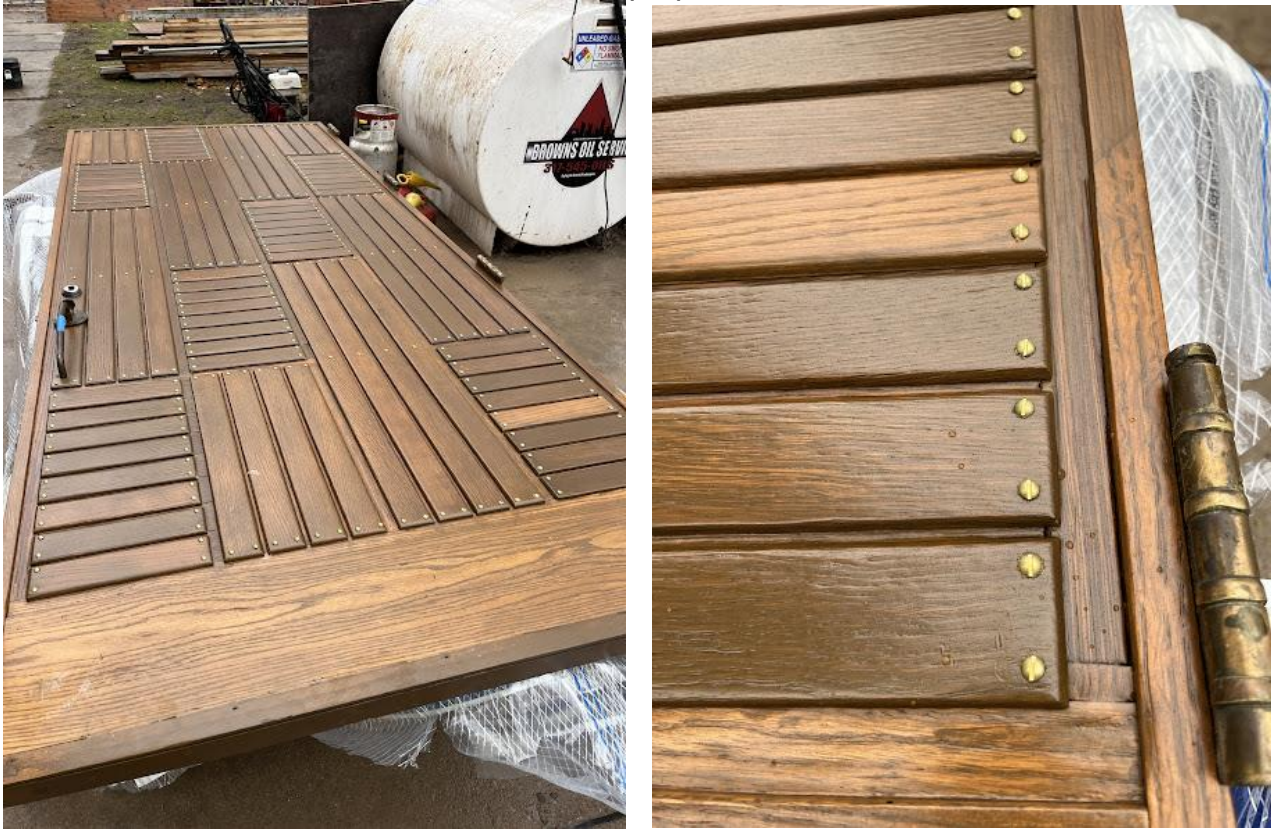
The tower door was returned after its refurbishment. A section that had been modified years ago, to accommodate a fan installed to aid in the tower's ventilation, was repaired and the door refinished. The door is shown below in preparation for reinstallation.

Note in the photo on the right, how the slots in the brass screws all line up and down. This feature is throughout the church and a unique and clever detail expressing the workmanship of the time of the church's original 1942 construction.

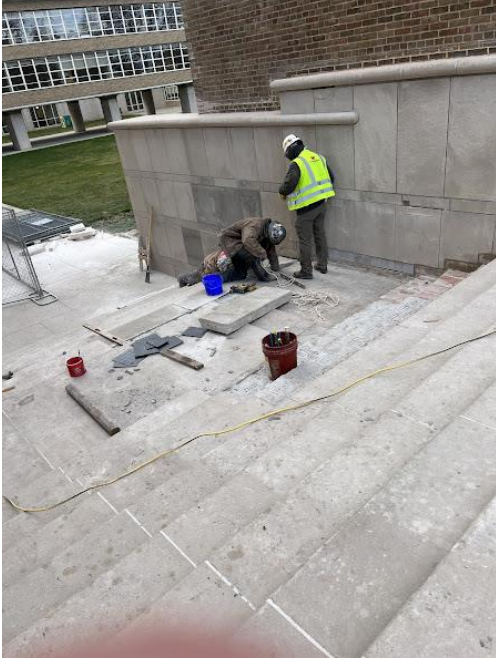
Work continued to focus on the clean-up and putting things back together. Some of the limestone step treads into the courtyard were removed to accommodate the base of one of the work platforms. Wilhelm employees are seen replacing those stair pieces below. In the same photo, four darker gray limestone panels, on the vertical wall just above the kneeling worker, were replaced because of their poor condition.

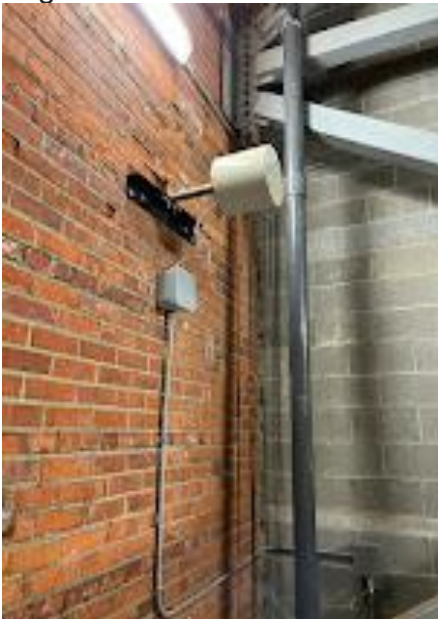
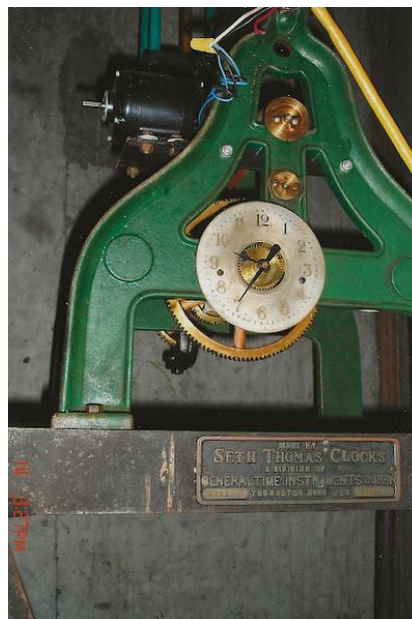
Below (left) is a photo of the new clock drive unit. It is entirely enclosed in the white cylinder, which is about the size of a gallon paint can. The mechanism is controlled from a cell phone app and will automatically change time between daylight savings time and standard time. The new clock was started on 11/28/2023 at 10 AM. The photo on the right is the original Seth Thomas clock movement installed in 1942.

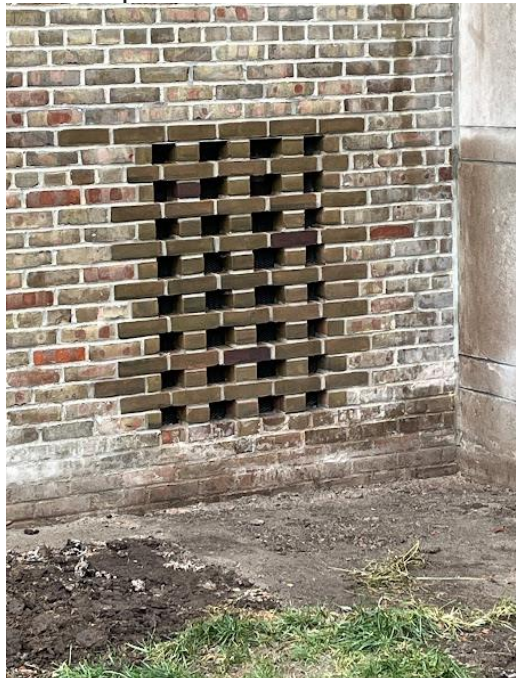
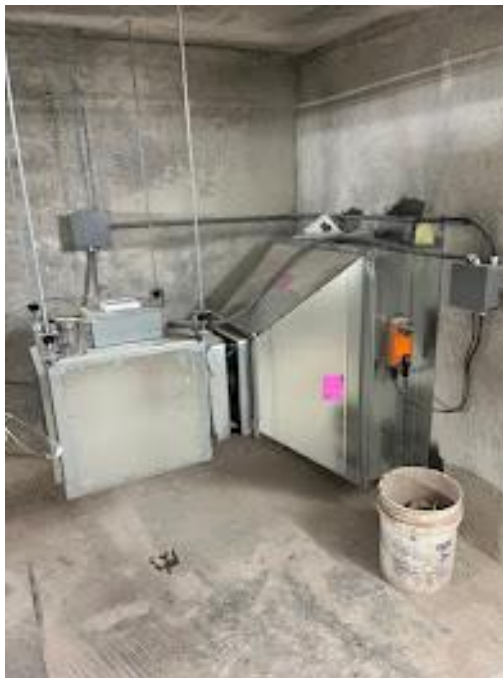
In the lowest level of the tower, a fan was installed (right photo below) to pull air into the tower and push it up through the interior to be exhausted. The space within the tower is now monitored for temperature and humidity. Air is tempered by an electric heater on the first floor as it flows up through the tower. This will prevent moisture from condensing on the interior walls especially in the spring and fall. The left photo is the new brickwork covering the damper on the south side of the tower's base.

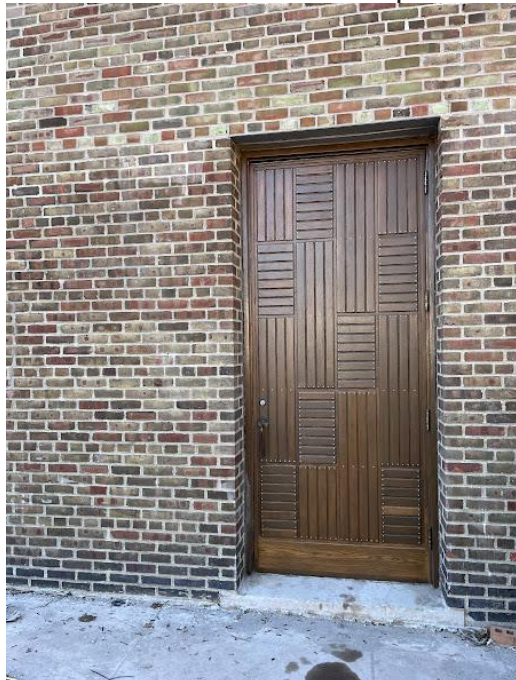
The tower door was reinstalled after being rebuilt to its original design. An exhaust fan that had been installed in earlier years and attached to the door to help extract moisture from the tower interior, was removed. This photo also shows the new brickwork just above the door where a rusted lintel was replaced.

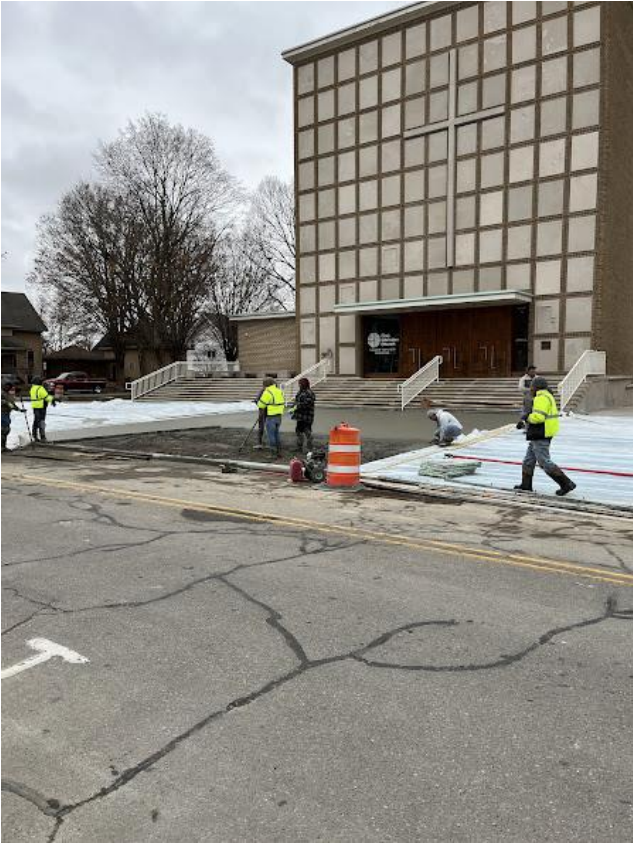
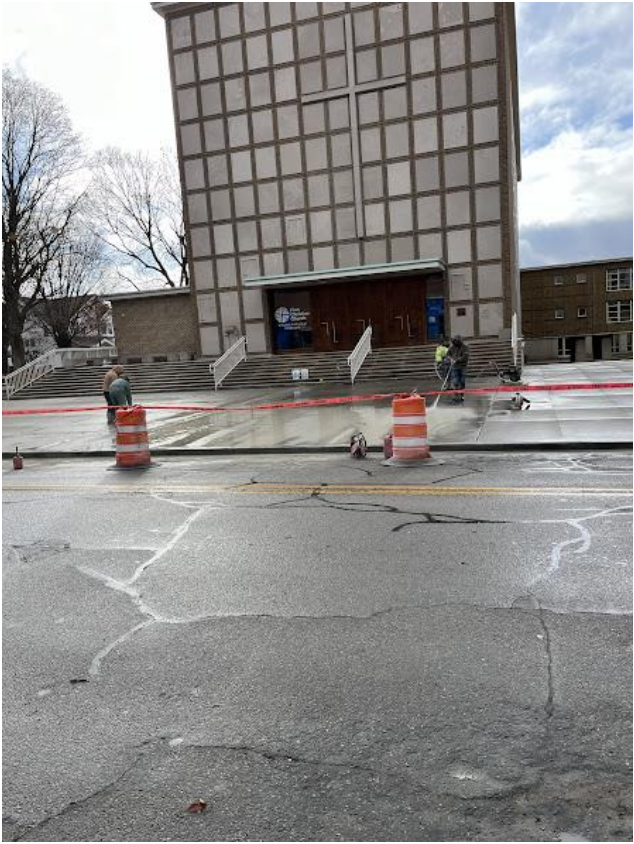
The photo below is of the work being done re-pouring and finishing the plaza the second time. A different crew was brought in to complete this work and the concrete mix was modified to accommodate the cold weather.

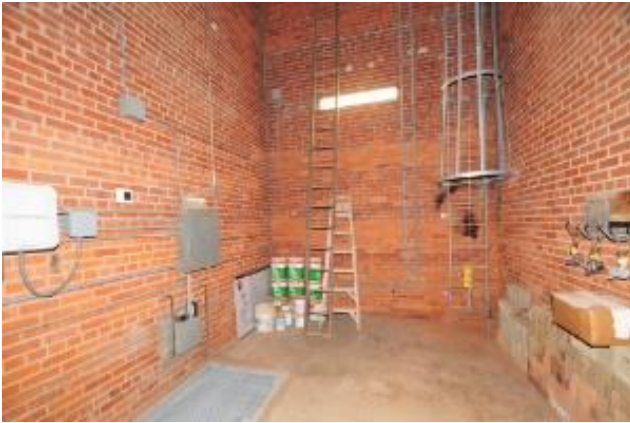
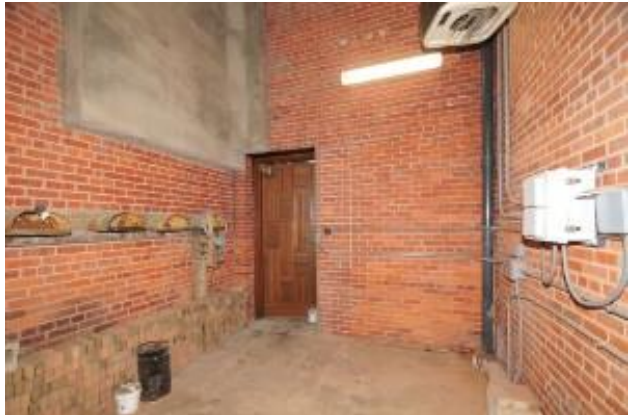
Ground Level Interior

New grating, lighting controls, high efficiency lighting that is controlled by motion detectors have been installed. The new ladder is equipped with a safety cage and a personal fall arrest system

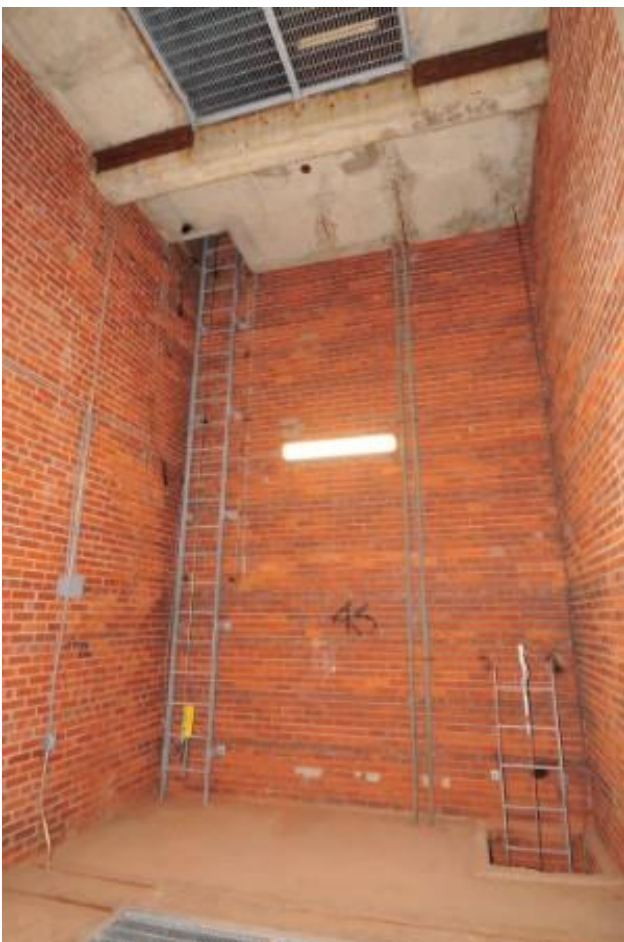
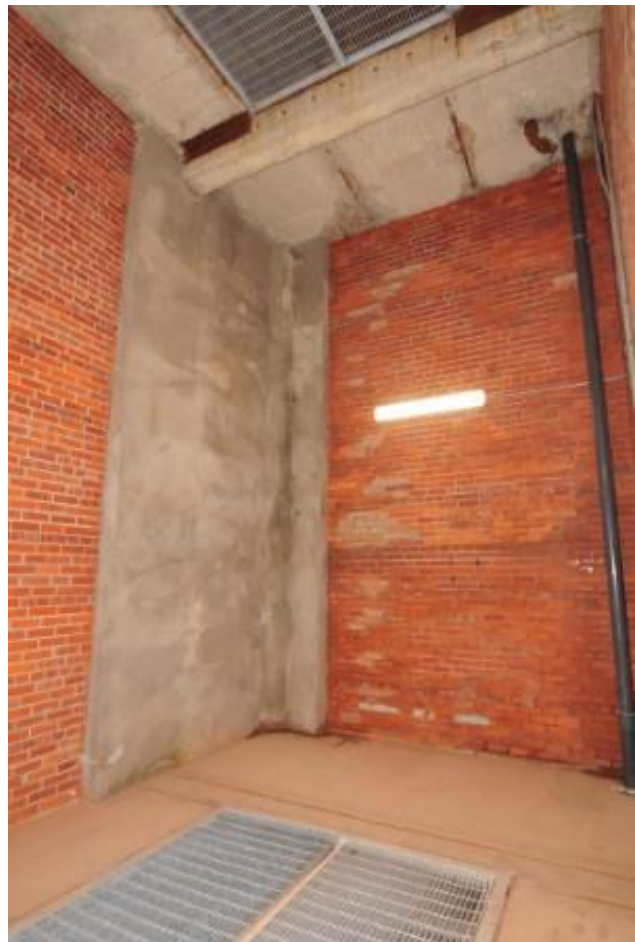
Levels B – D (Typical)

Levels B – D are identical and their floors are integral to the tower's structural strength and rigidity. The concrete "patch" in the NW corner, that runs from the first floor to just below the bell chamber can be seen in the right photo.

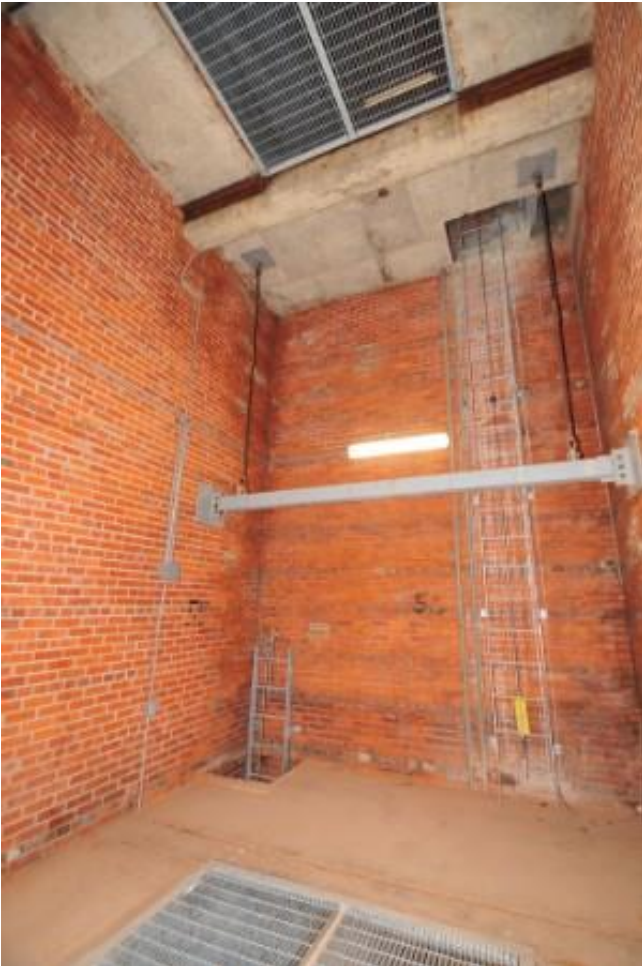
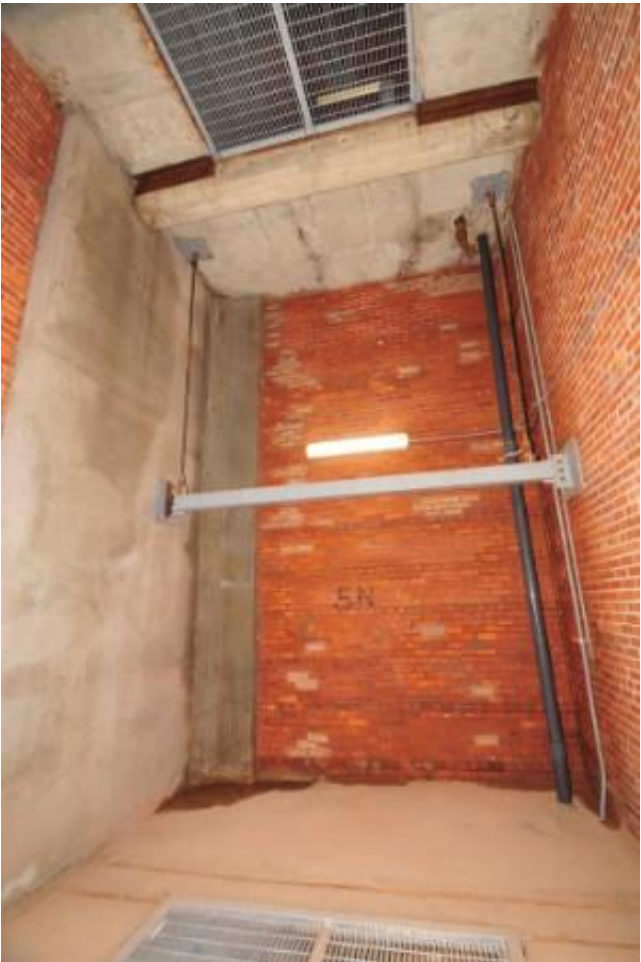
Level E is one floor below the bell chamber. New structural steel reinforcement was added along with new lighting, electrical conduit, galvanized grating and the storm drain.
