First Christian Church Tower Renovation

FIRST CHRISTIAN CHURCH
531 FIFTH ST., COLUMBUS, INDIANA

Introduction

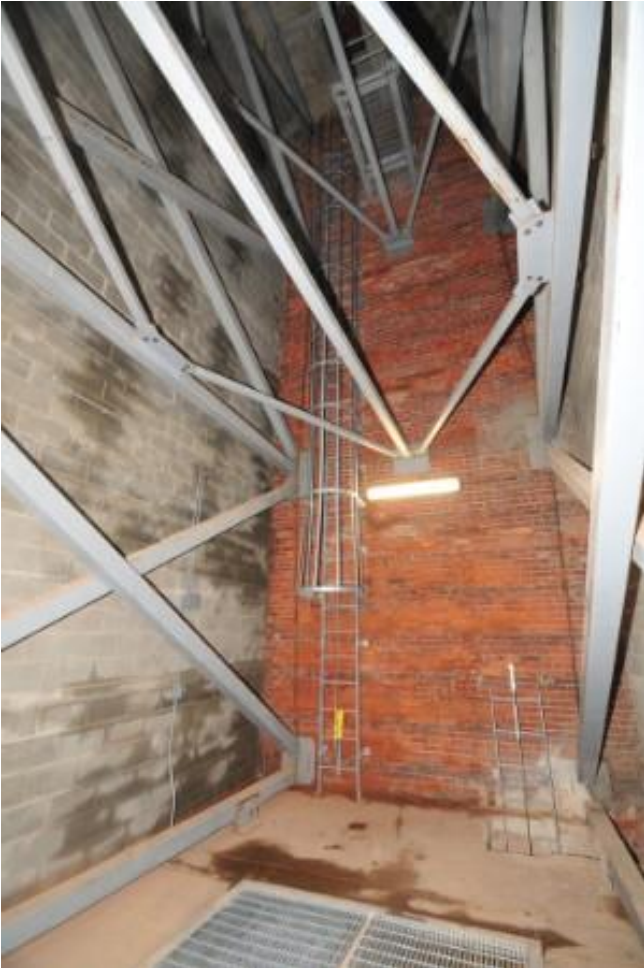
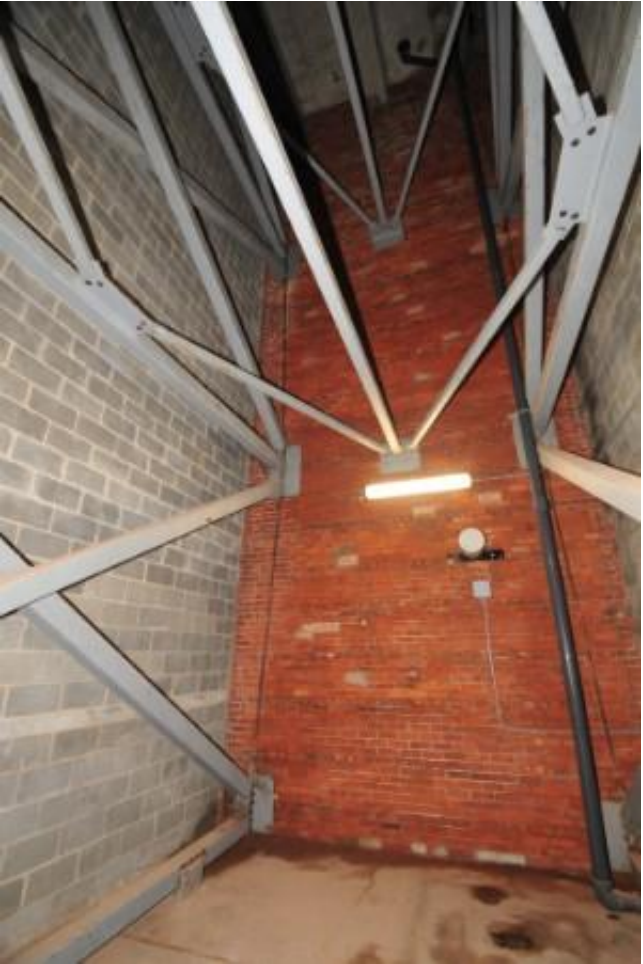
Level F (Bell Chamber)

The bell chamber or uppermost floor received the most work. Steel was added as one of the first steps in the reconstruction. This was to provide stability and strength to the upper chamber while the windows and their brick frames were removed and the new concrete block walls were constructed. Also visible is the upgraded clock drive mechanism with close-up photos shown below.

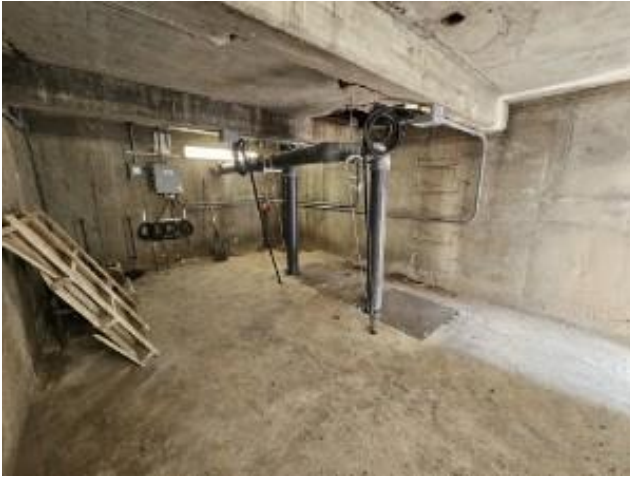
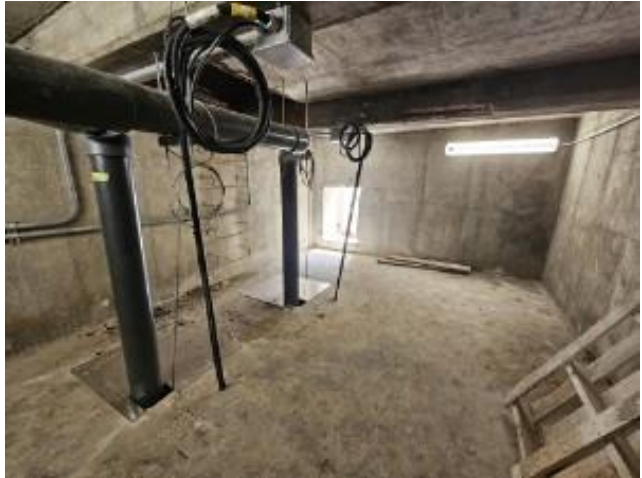
Utility Level

Updated lighting, sump pump piping and pump controls were added to the utility level. In the photo on the right the opening for the new ventilation fan can be seen in the right photo prior to the fan's installation. The sump pumps are located below this floor in a wet well.
